Accessibility Report

VIFF Centre

April 2022

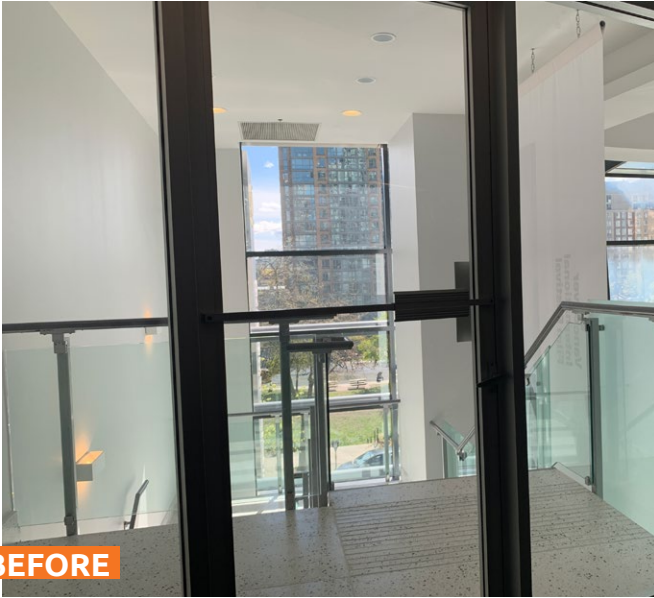
BEFORE

- **Glazed walls and doors**

Currently, glazed walls and doors lack any contrasted markings or stripes. This is a hazard and barrier for people with low vision, who may not detect the glass or have trouble differentiating between the doors and walls.

Left: Glazed doors do not have markings or strips to indicate their presence.

Consider installing two contrasted strips at two levels on glazed doors and (where appropriate) walls.

Right: Two colour-contrasted strips on the glazed doors. The higher strip is at a height of around 1500 mm AFF, with the lower strip around 900 mm AFF.

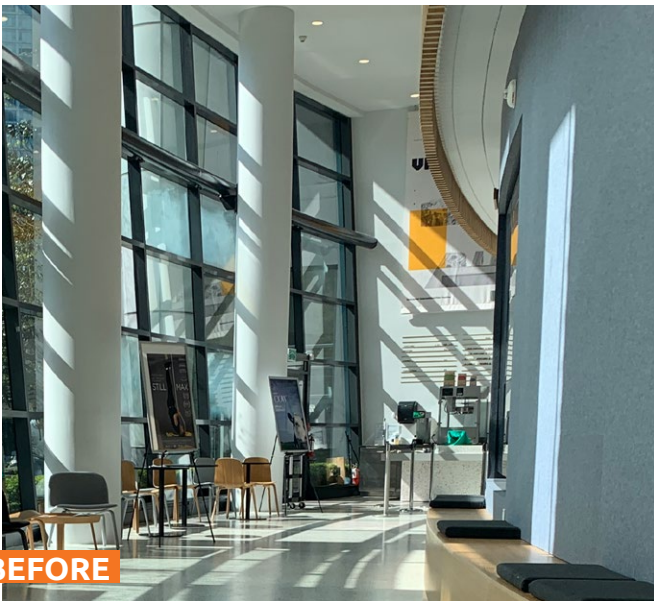
BEFORE

Currently, there are entrances to the theatres that are reachable via long hallways, without directional signage. This is a barrier for people with low vision or stamina issues, who may benefit from knowing for certain where the theatre entrances are located.

Left: Theatre entrances are not visible from the corridor.

Consider blade signage that direct users to the theatre entrances.

Right: Blade signage indicating where to go to reach the theatre door.

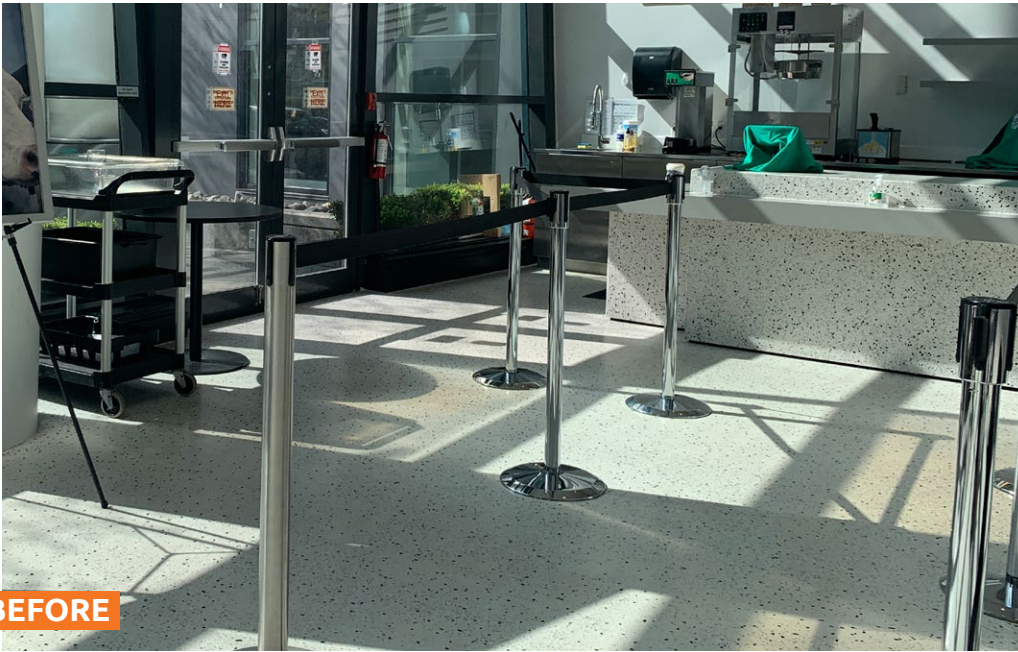
BEFORE

Currently for roped areas with queuing guides, only one height is available without colour contrast. This is a barrier for people with low vision, who may not be able to identify or detect the queuing guides with blind canes.

Top: Queueing guides are not colour-contrasted and at one height.

Consider queuing guides with colour contrast, available at two levels (lower ribbon at 685 mm AFF) to allow for blind cane detectability.*

Bottom: Two colour-contrasted ribbons at two heights. The bottom ribbon's height is 685 mm AFF or lower, to allow for blind cane accessibility.

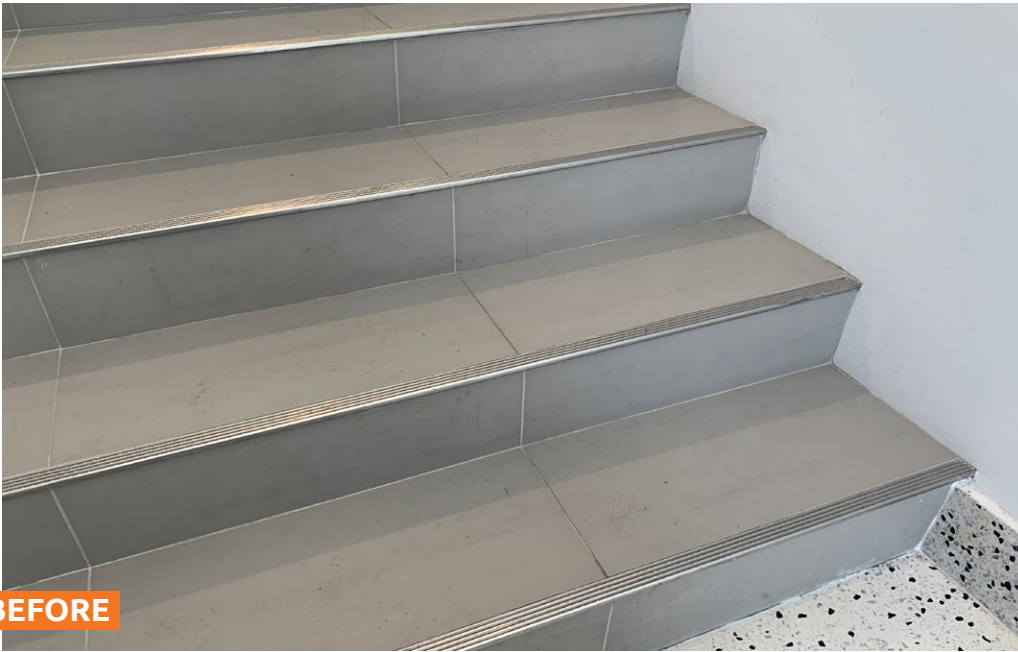
BEFORE

Currently, some interior stairs do not have colour contrasted nosing strips. This is a hazard for people with low vision, who may have trouble differentiating between each step.

Top: Interior stairs without colour-contrasted nosing and riser strips.

Consider adding colour contrasted nosing and riser strips at each step.

Bottom: Colour-contrasted nosing and riser strips, visible while looking down and up the stairs.

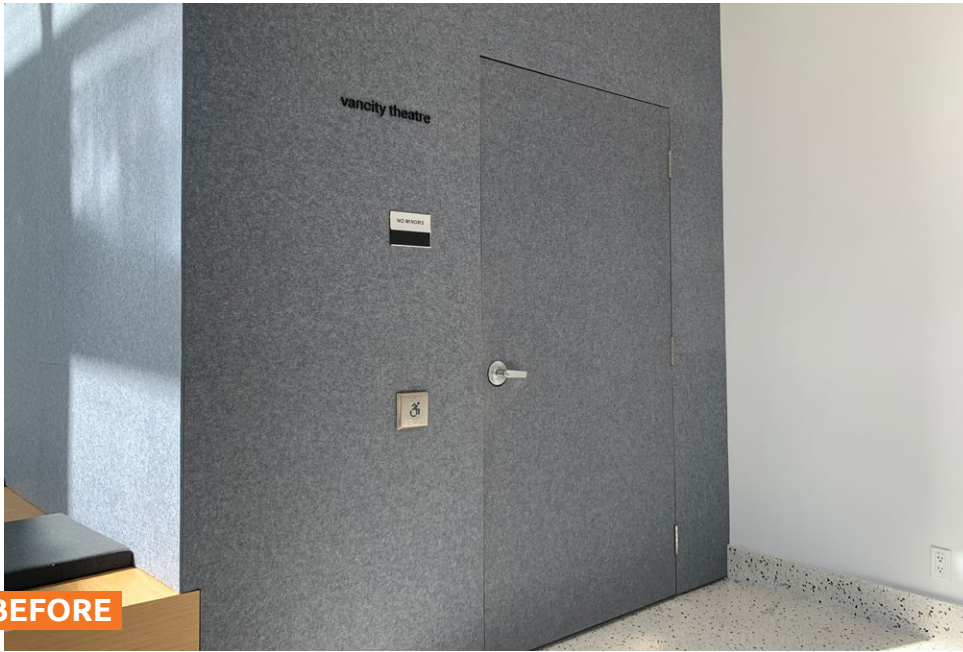
BEFORE

Currently, interior doors (including to the theatre) are not colour contrasted. This is a barrier for people with low vision, who may have trouble identifying the theatre entrance.

Top: Room signage and entrance door are not colour-contrasted. Power-operated door button is only at one height.

Consider using a contrasted colour for interior doors.

Bottom: Room signage is colour-contrasted, with raised lettering and braille. Entrance door is colour-contrasted with an “automatic door” warning sticker. Power-operated door button is now a vertical actuator button.

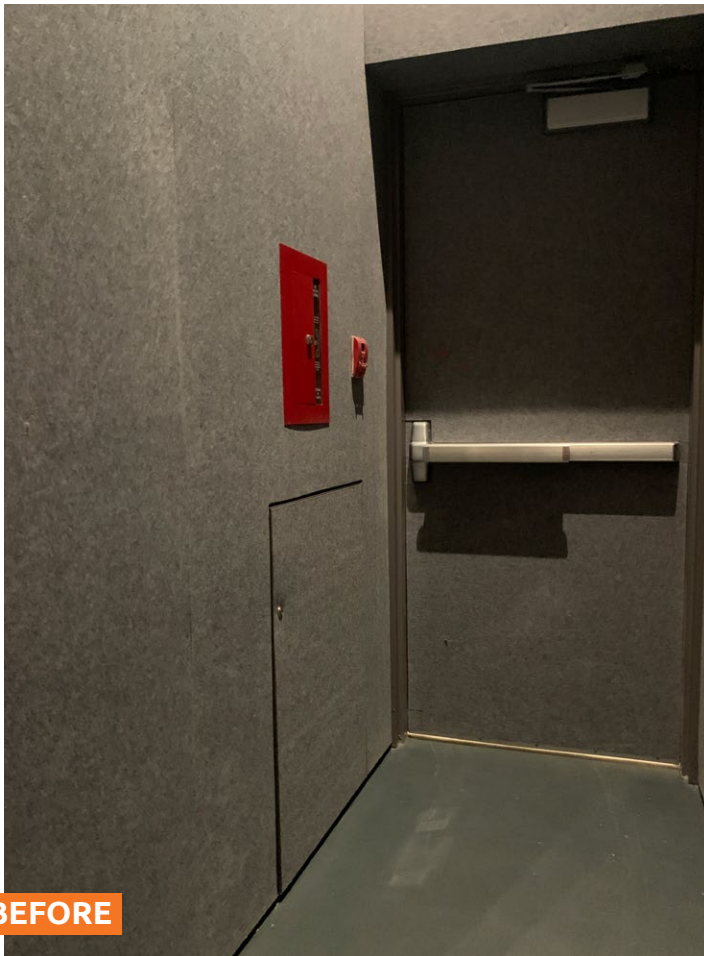
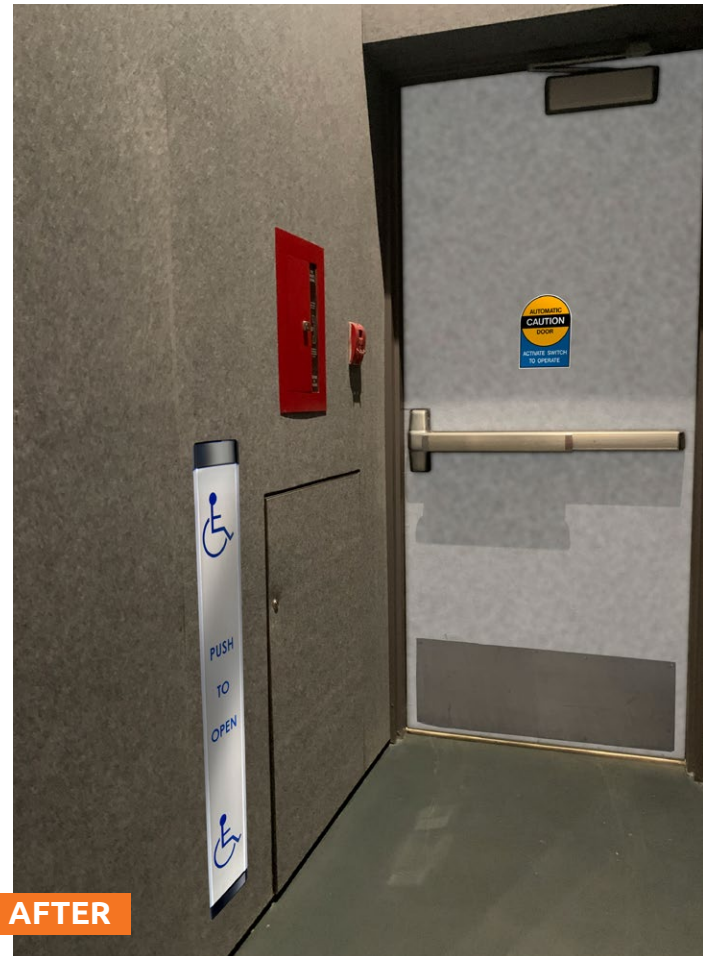
Top: For the Studio Theatre, there is no colour contrasted or power-operated door.
Bottom: Theatre door is colour-contrasted with an “automatic door” warning sticker. There is a vertical actuator button for a power-operated door.

Consider installing a power-operated door, with a vertical actuator control button to accommodate people with both lower and upper limb differences or impairments.

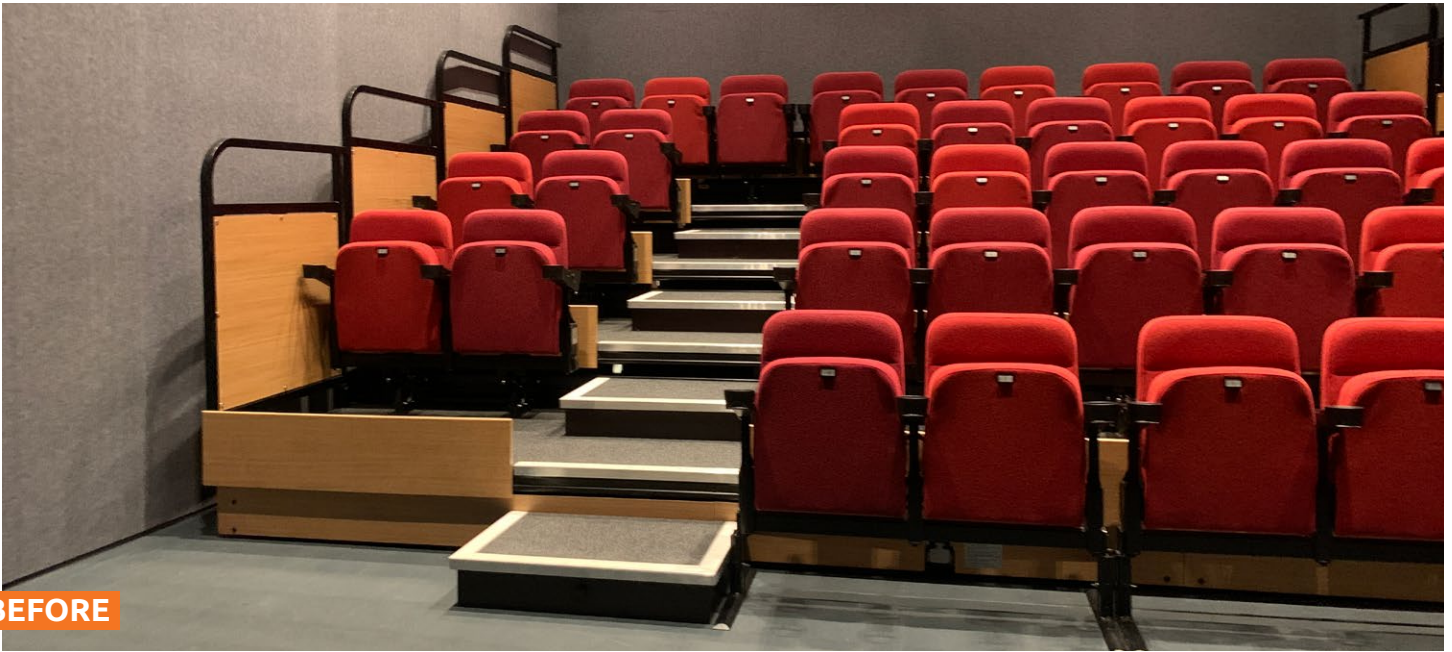
BEFORE

Currently, the accessible seating at the Studio Theatre downstairs does not have signage indicating its function. This can lead guests without disabilities to use the space for storage and guests with disabilities may have trouble identifying the space.

Top: Accessible seating area is not marked and has a low back, allowing wheelchair backrests or backpacks to encroach into the row behind.

Consider adding signage to accessible seating, as well as increase heights of backboards to accommodate power wheelchairs (so any wheelchair parts or backpacks will not intrude into the guest behind them).

Bottom: Accessible seating area is clearly marked with high-contrast signage and a higher back board.

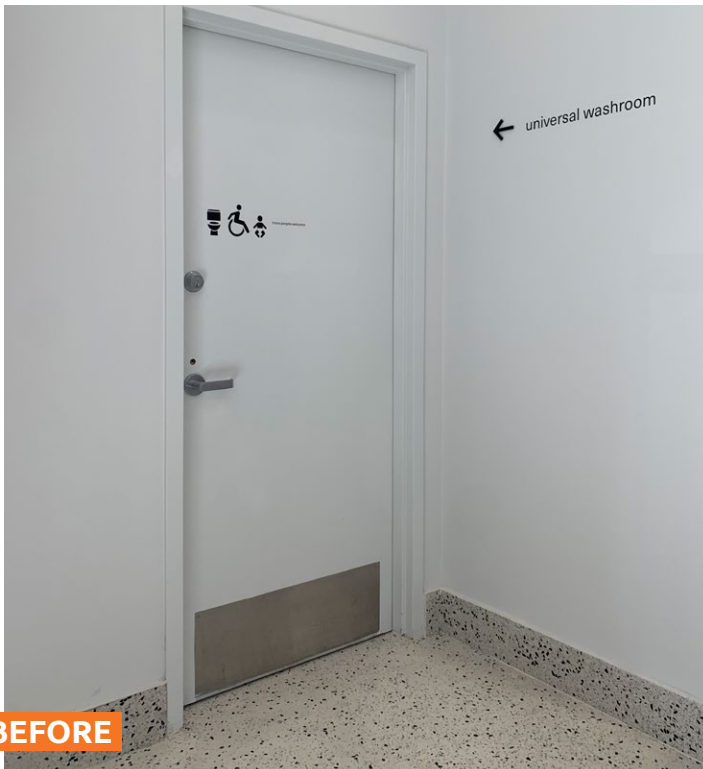
BEFORE

Left: Washroom signage lacks braille or raised lettering. Door is not power-operated or colour-contrasted. Directional signage may be hard to see from afar.

Right: Washroom signage has braille and raised lettering, with colour contrast. Door is power-operated via vertical actuator button, and colour-contrasted. Additional icons are added to directional signage, enhancing visibility from afar.

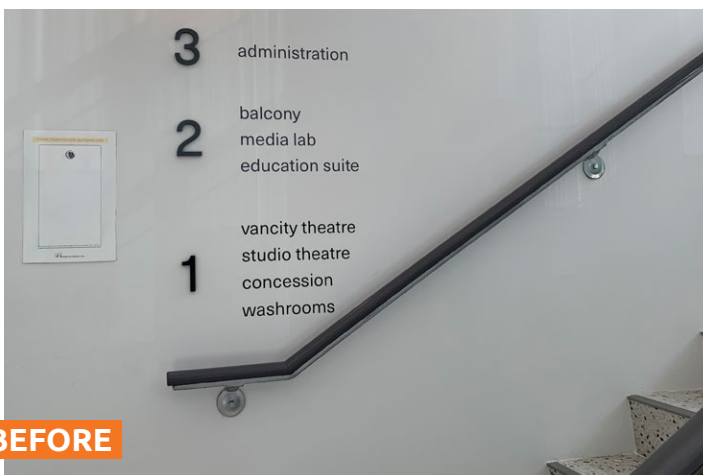
BEFORE

Currently, there is a list of destinations at each floor near the stairs, with a slightly different colour indicating which floor the user is at. This is a barrier for those who have low vision or colour blindness.

Left: Current floor is not indicated by a colour-contrasted visual cue.

Consider a circle around the floor number to indicate the current floor.

Right: Current floor is indicated by a circle around the floor number.

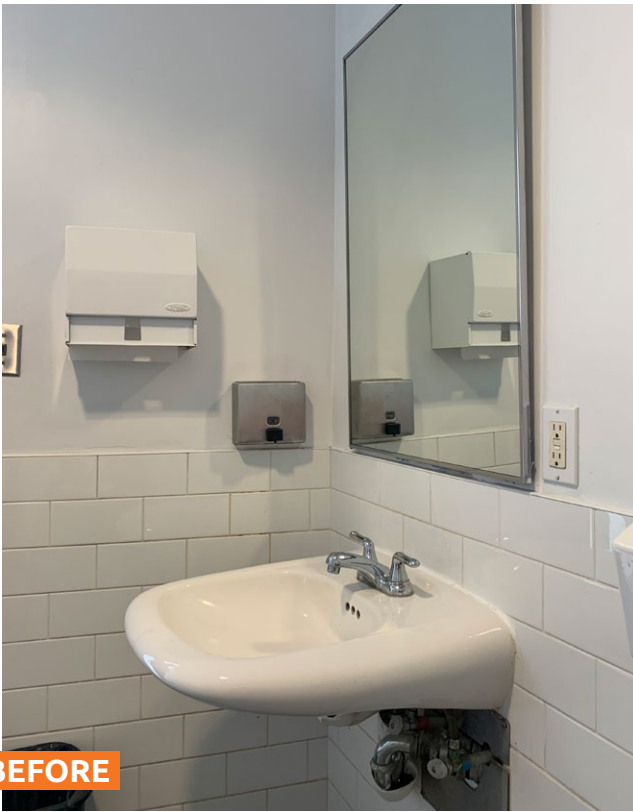
BEFORE

Currently, mirror and fixtures in the universal washroom are slightly too high or out of reach from a sitting position. This is a barrier for wheelchair users, as well as anyone who is shorter.

Left: Washroom mirror is too high for wheelchair users. Towel and soap dispensers are too far or too high.

Consider lowering the mirror to the sink height, and fixtures (such as the towel and soap dispenser) to 950-1100 mm AFF.

Right: Washroom mirror is lowered. Towel and soap dispensers are also lowered; the towel dispenser's height is around 1100 mm AFF and soap dispenser is around 950 mm AFF. (Heights are lower than usual due to clear space being obstructed by the sink.)

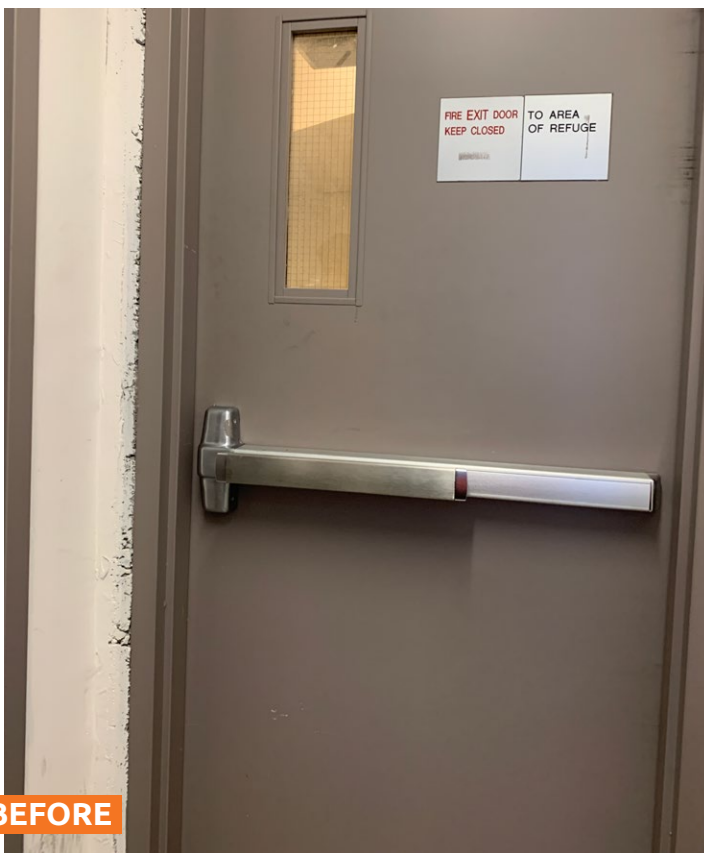
BEFORE

Currently, emergency exit signage on the door are not highly visible from afar. This can be a hazard for people with low vision or situations where visibility is limited.

Left: Emergency exit doors have small text on signage, without icons. The door also has a high and narrow vision panel.

Currently, vision panels on emergency exit doors are high. This is a hazard for those who are shorter, who may open the door into another person.

Consider signage with icons and large high-contrast sans-serif typeface, indicating areas of refuge where applicable.

Right: Signage has icons and increased font. Vision panels now extend to the bottom of the door to enhance visibility.

Consider installing a door with two vision panels, spanning from eye-level to bottom.

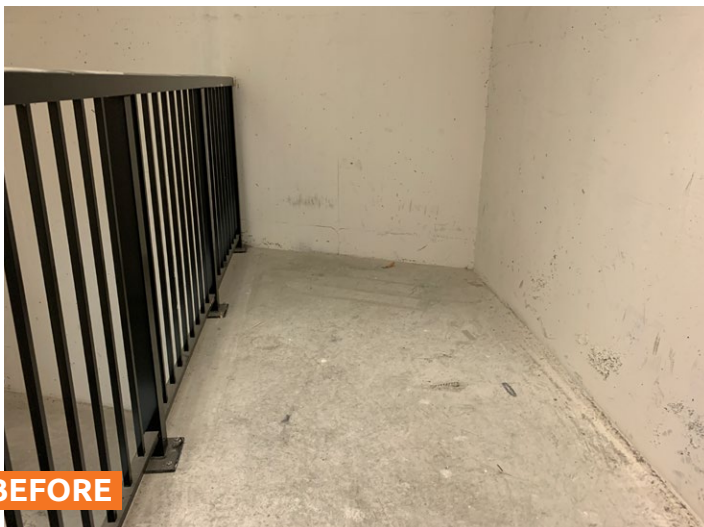
BEFORE

Currently, areas of refuge are not clearly marked. This can lead the space to be cluttered and used for storage, which is a hazard for emergency situations where the space is needed.

Left: Area of refuge lacks signage, which can prevent the space being used for storage.

Consider clearly marking the area of refuge with signage.

Right: Area of refuge signage with both text and icons.

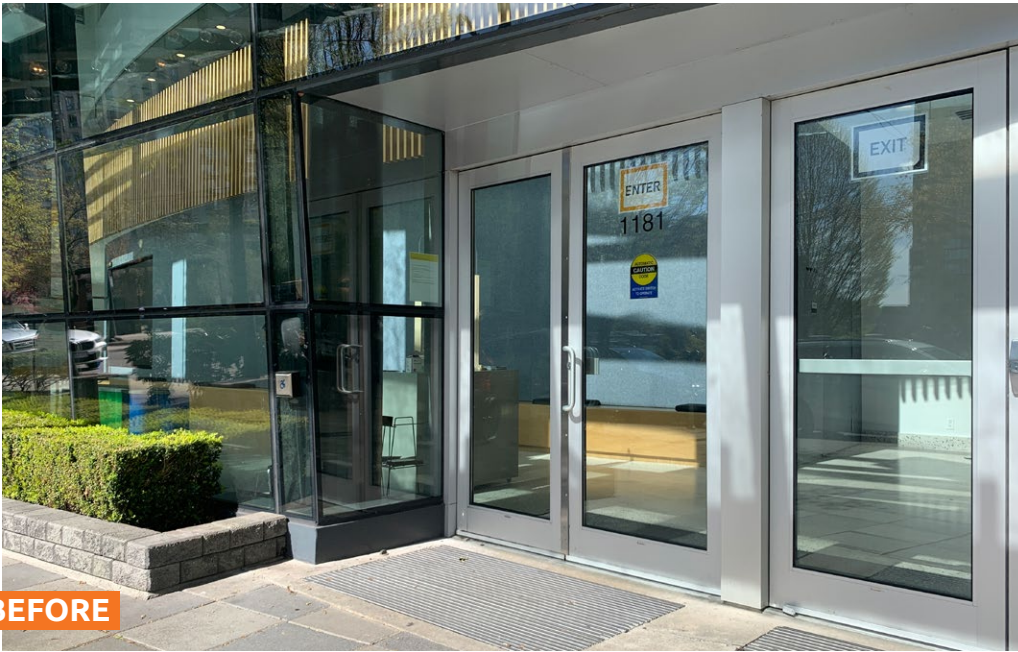
BEFORE

Currently at the front entrance, the power-operated door button's clear space is partially obstructed by bushes. This is a barrier for wheelchair users, who may not be able to approach the button adequately or lean forward enough to reach it (possible for users with chest straps).

Currently at the front entrance, the power-operated door button is available at one height. This is a barrier for people with upper limb differences or amputations, as well as wheelchair users with limited hand and arm use.

Top: Glazed entrance doors and walls lack markings or strips on the glass. Power-operated door button is at one height and clear space is obstructed by shrubbery.

Consider making the button face northwards. (It currently faces eastwards.)

Consider adding a vertical actuator button, or buttons at two levels (1100-1200 mm AFF and 200 mm AFF).

Bottom: Doors have colour-contrasted strips at two heights; walls have one strip, as there is a window pane that acts like a strip. Power-operated doors are activated via vertical actuator button, which has clear space in front.

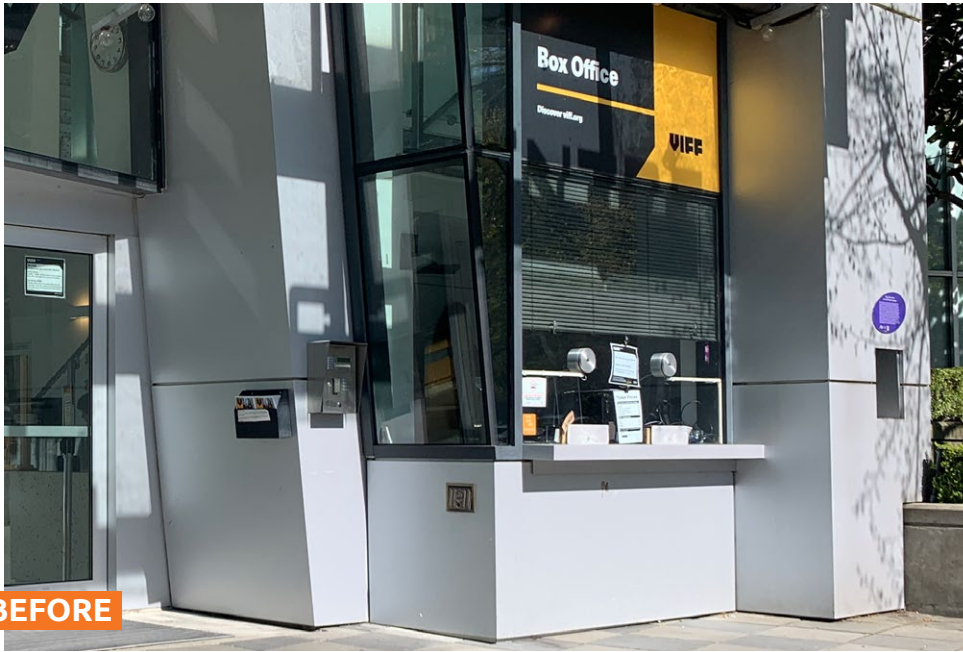
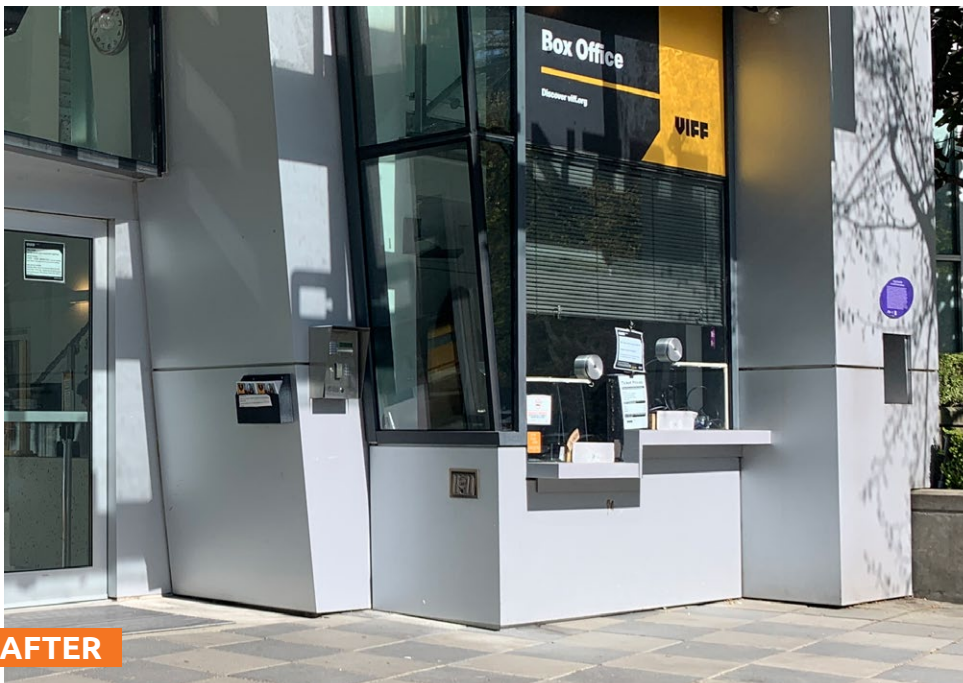
Currently, the box office window is only available at one height. This is a barrier for people in wheelchairs or who are shorter.

Top: Box office counter is available at only one height.

Consider adding a lower counter option, with a bottom height / knee clearance of 685 mm AFF and 200 mm deep.

Bottom: Box office with a lower height for wheelchair users and those who are shorter. There should be a knee clearance height of 685 mm AFF.

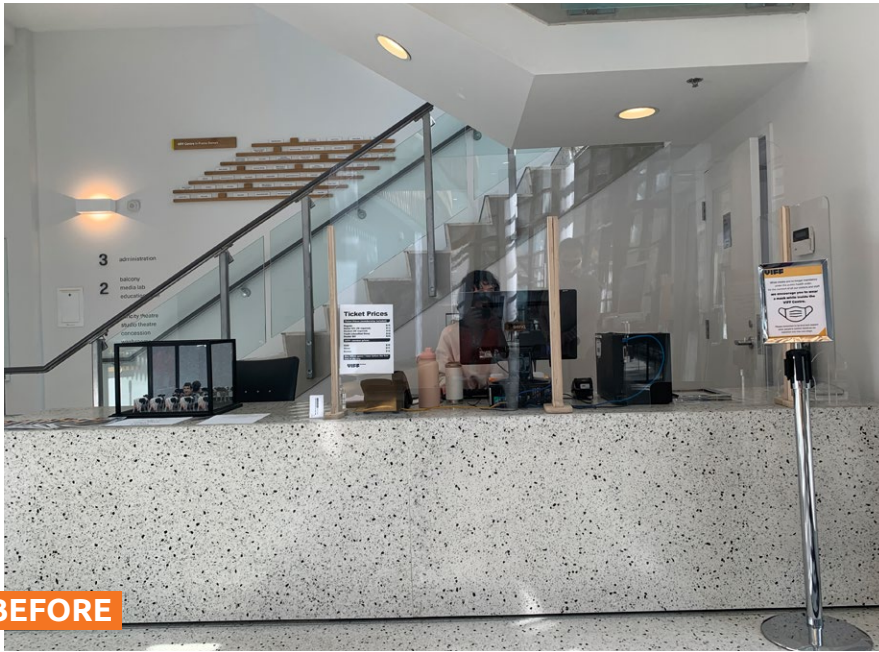
BEFORE

Currently, the reception and information desk does not have signage indicating its function. This is a barrier for those who have low vision, or unfamiliar with the building.

Currently, the reception and information desk does not have knee clearance underneath. This is a barrier for those who use wheelchairs, who may have to approach the desk to fill out forms, make payments, etc.

Top: Information desk has no knee clearance for approach by wheelchair users. There is no signage.

Consider adding signage indicating the reception desk's role.

Consider adding knee clearance underneath for the public, at a height of 685 mm AFF and depth of 200 mm.

Bottom: There is knee clearance underneath (685 mm AFF high and 200 mm deep). There is signage above the desk, with icons, colour contrast, and sans-serif typeface.

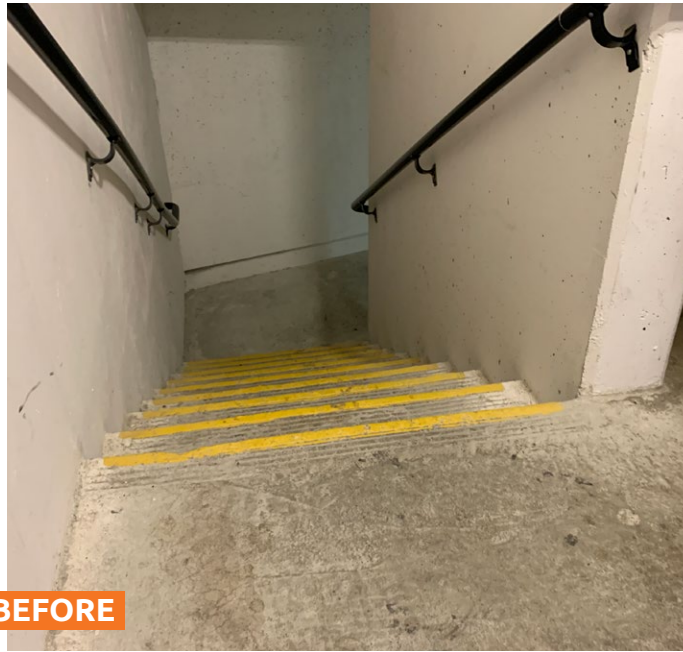
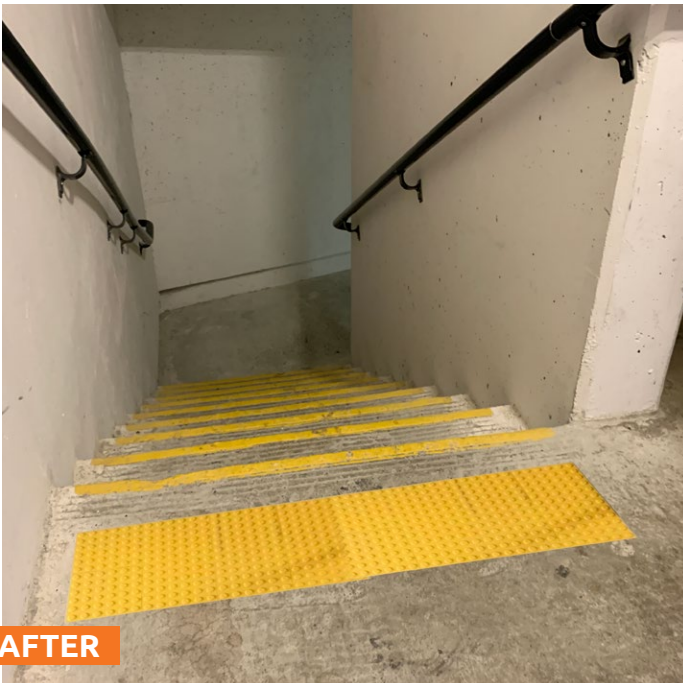
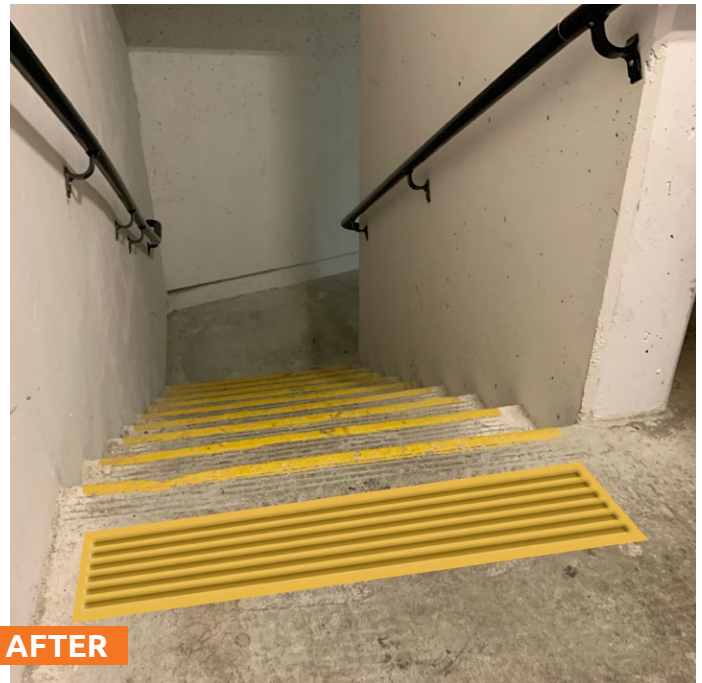
Currently for some (but not all) interior staircases, there are no tactile indicators at the top. This is a hazard for people with low vision, who may need a warning that the pathway is about to turn into stairs.

Top: Emergency stairwells without tactile attention indicators.

Consider adding tactile attention indicators to the top of the stairs.

Bottom left: Tactile attention indicators, with truncated domes and colour contrast. This is best practice.

Bottom right: Tactile slots with colour contrast. This is not best practice but still meets minimums for interior (indoor) stairs.

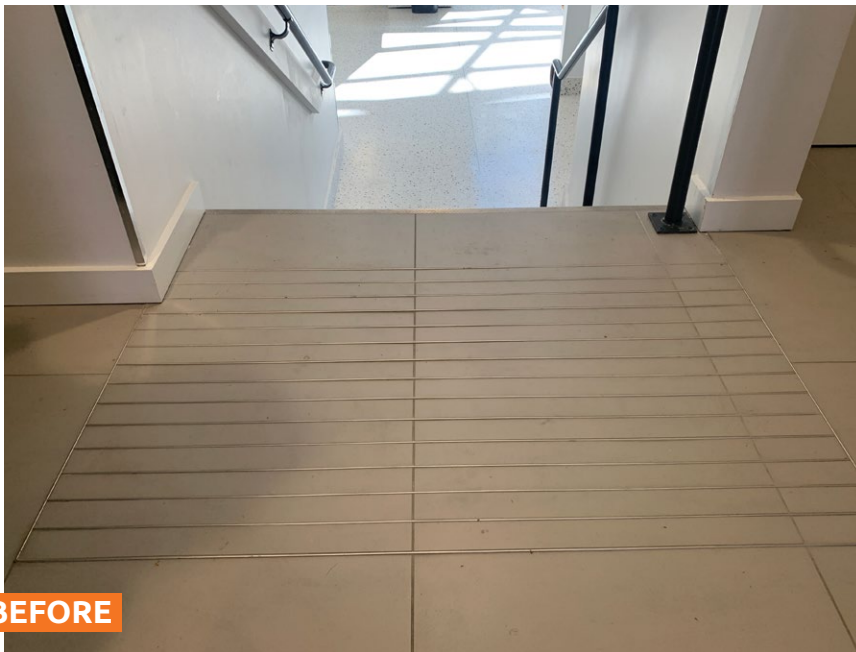
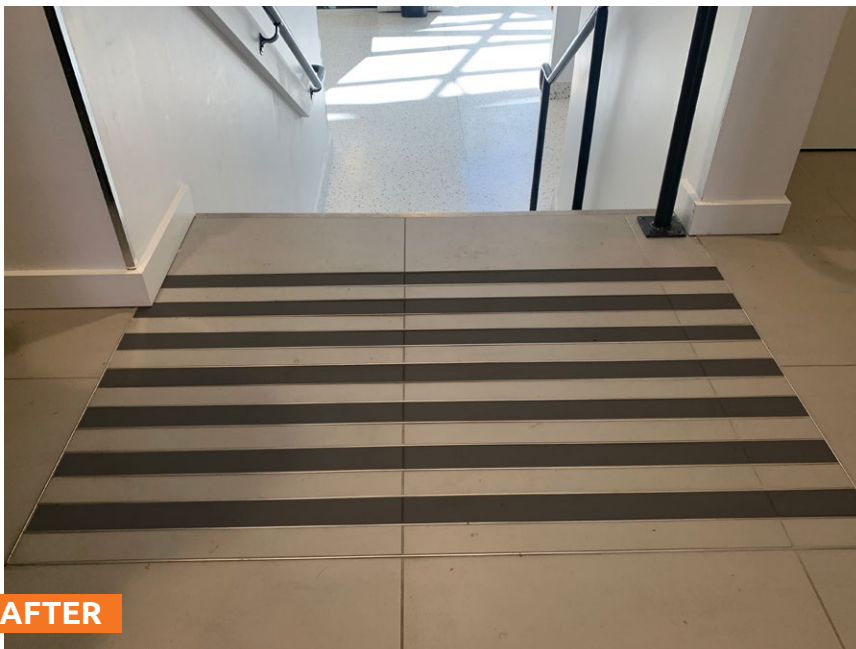
Top: Tactile indicators without colour contrast.

Bottom: Tactile indicators with colour contrasted strips, as a supplemental warning feature for people with low vision.

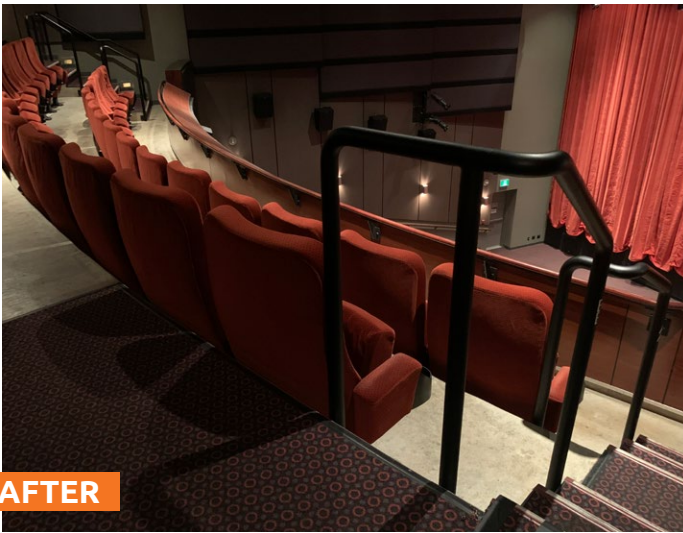
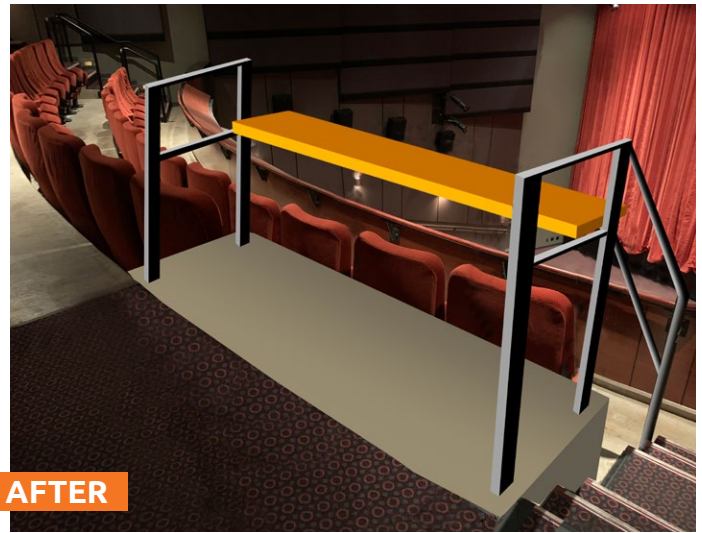
Currently, the accessible seating area has a railing that obstructs wheelchair users' sight lines and is not clearly marked.

Currently, there is no ledge for users to set down phones, snacks, etc. This is a barrier for wheelchair users, who may not be able to balance such items on their laps or cannot use the floor space due to sizes of wheelchairs.

Top: Upper balcony does not have accessible seating options.

Consider lowering the rail in front of the seating area and clear signage that indicates the accessible seating area.

Consider adding a ledge to the accessible seating area.

Bottom: Possible accessible seating, with a railing low enough not to obstruct the line of sight and a ledge to store phones, snacks, or other items. (The same idea may be applicable to the existing accessible seating below, if possible.)
