Accessibility Report

VIFF Centre

April 2022

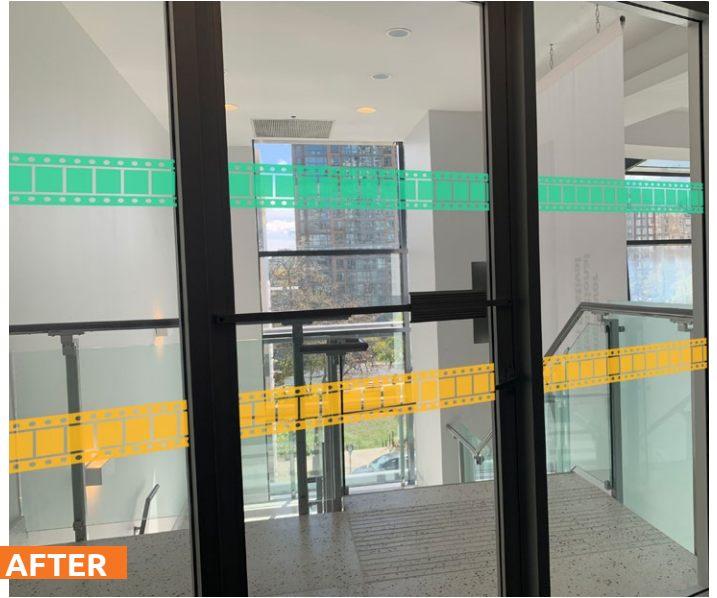
Currently, glazed walls and doors lack any contrasted markings or stripes. This is a hazard and barrier for people with low vision, who may not detect the glass or have trouble differentiating between the doors and walls.

Left: Glazed doors do not have markings or strips to indicate their presence.

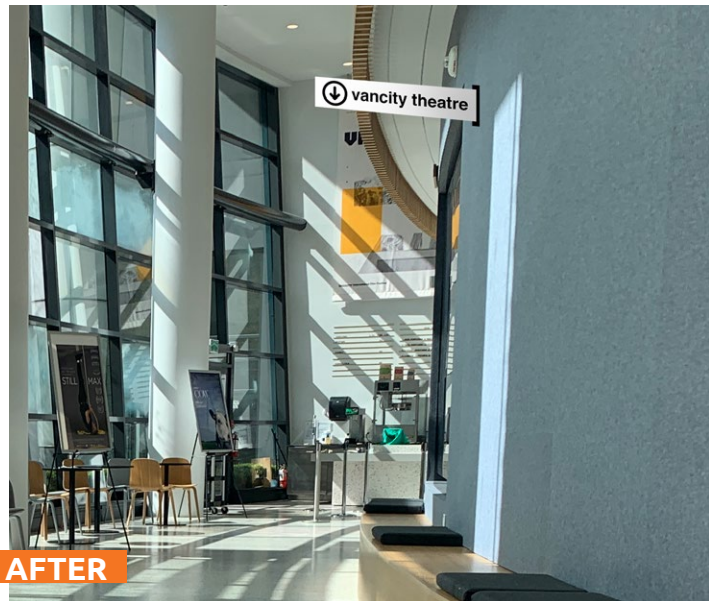
Left: Theatre entrances are not visible from the corridor.

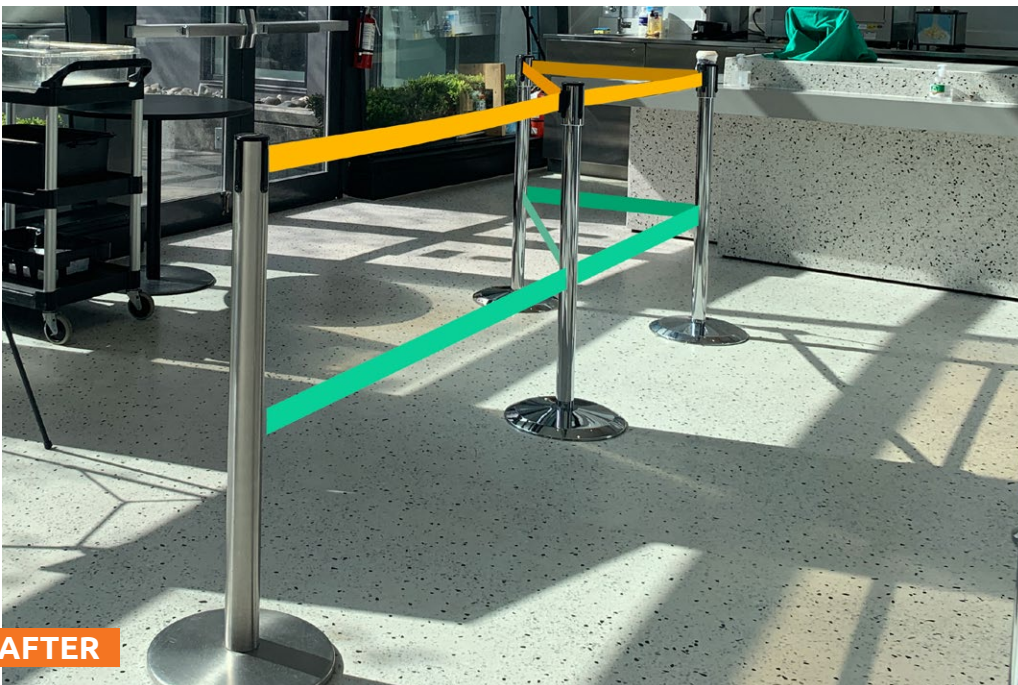
Top: Queueing guides are not colour-contrasted and at one height.

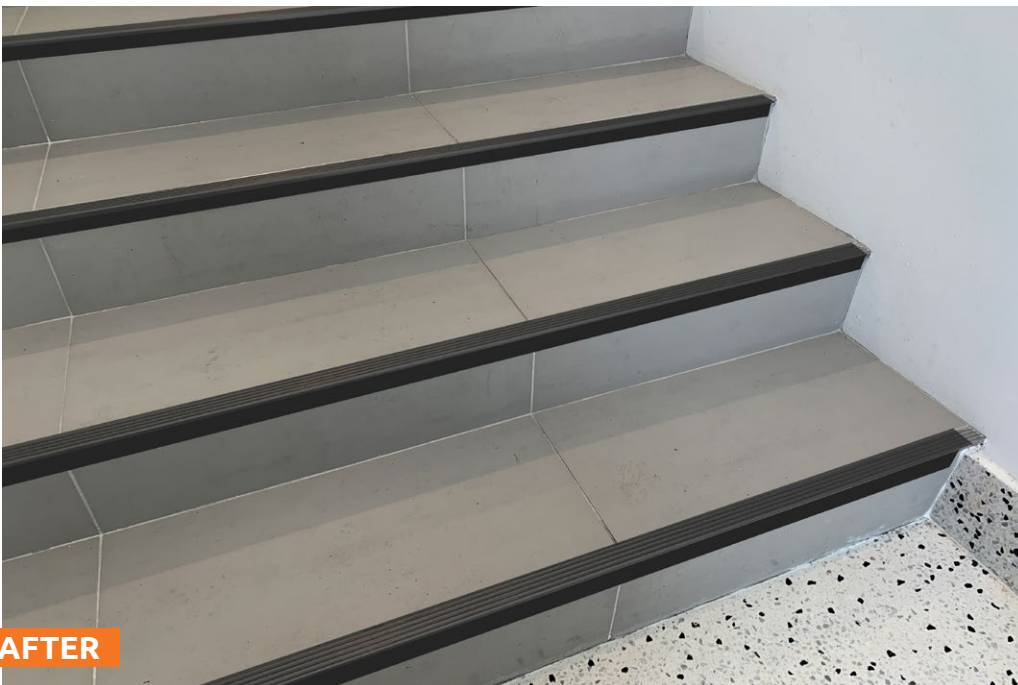
Currently, some interior stairs do not have colour contrasted nosing strips. This is a hazard for people with low vision, who may have trouble differentiating between each step.

Top: Interior stairs without colour-contrasted nosing and riser strips.

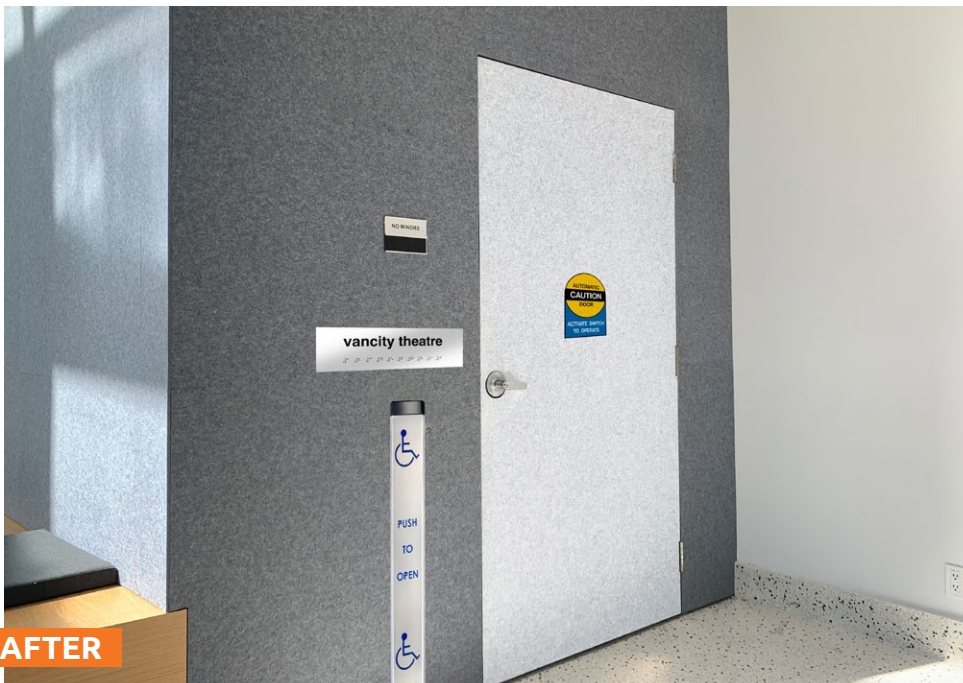
Top: Room signage and entrance door are not colour-contrasted. Power-operated door button is only at one height.

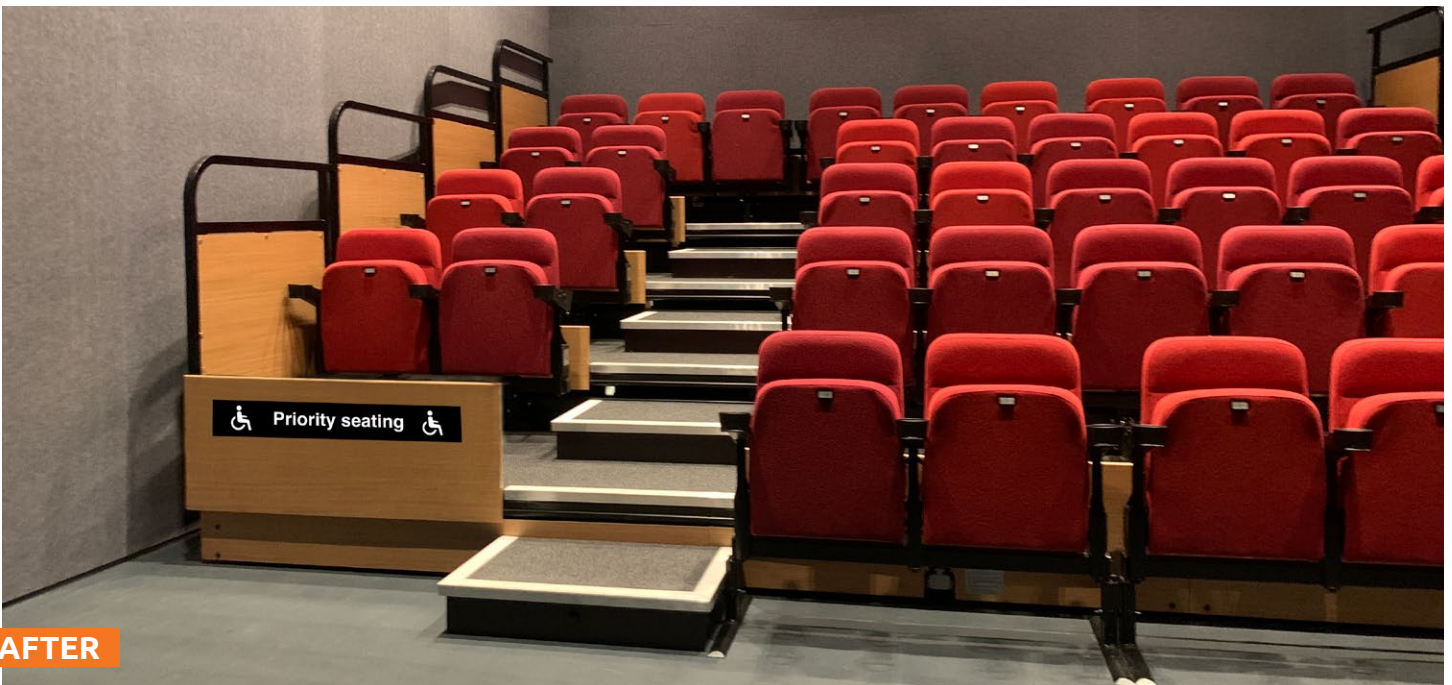
Top: Accessible seating area is not marked and has a low back, allowing wheelchair backrests or backpacks to encroach into the row behind.

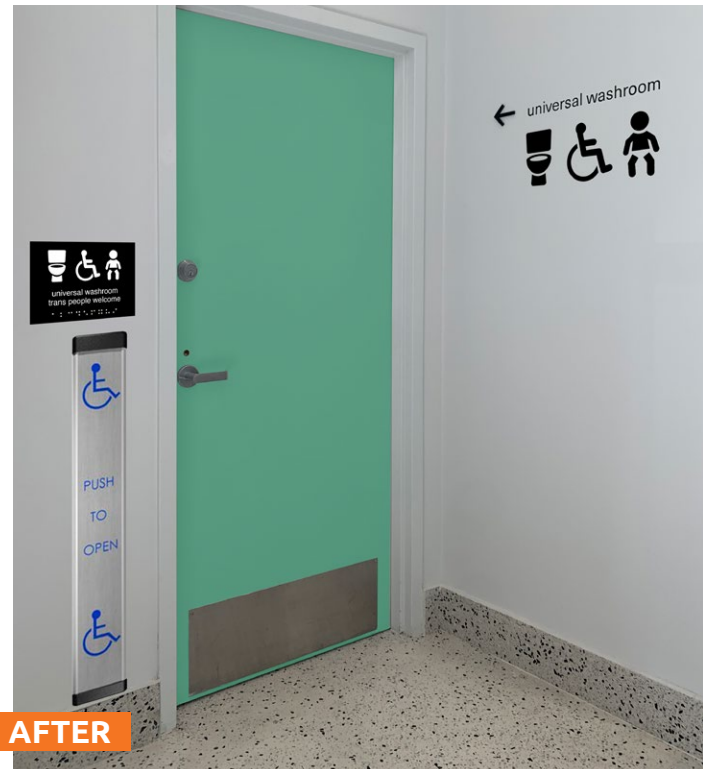
Left: Washroom signage lacks braille or raised lettering. Door is not power-operated or colour-contrasted. Directional signage may be hard to see from afar.

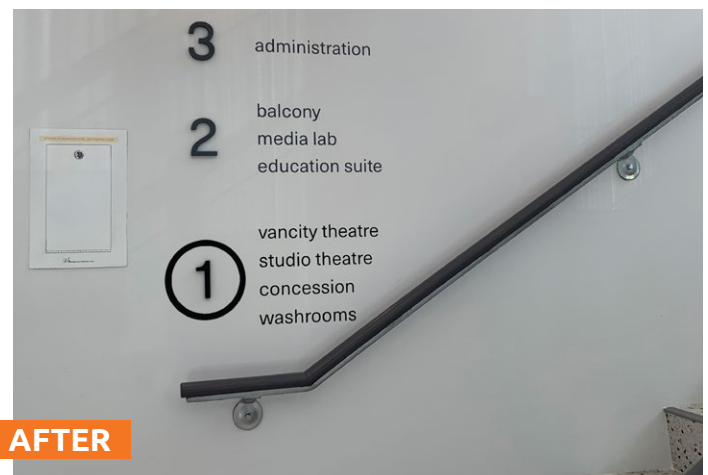
Left: Current floor is not indicated by a colour-contrasted visual cue.

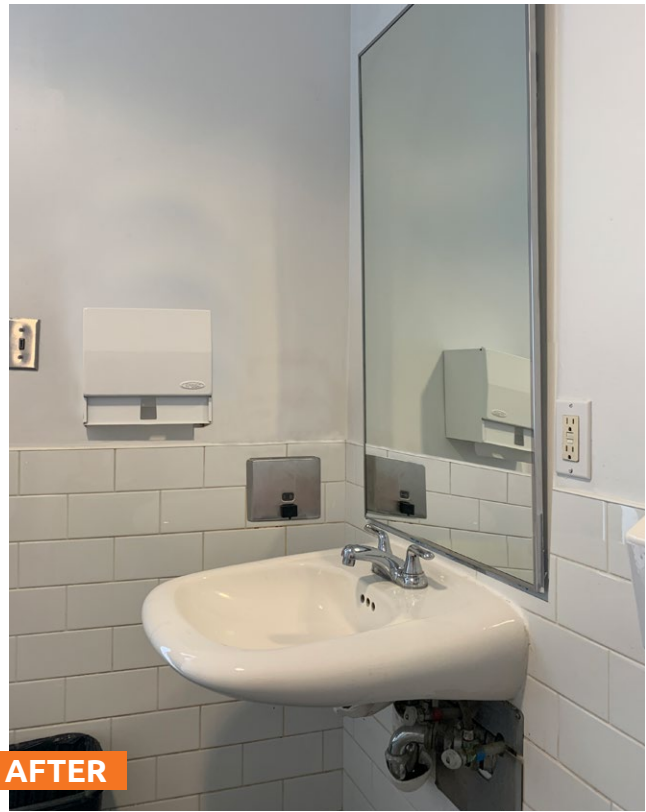
Left: Washroom mirror is too high for wheelchair users. Towel and soap dispensers are too far or too high.

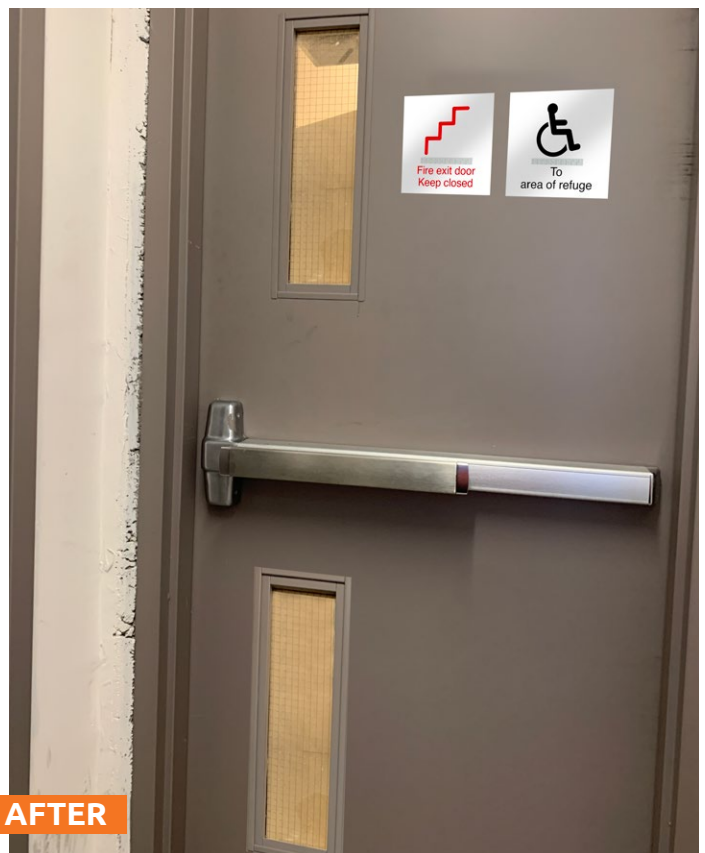
Currently, emergency exit signage on the door are not highly visible from afar. This can be a hazard for people with low vision or situations where visibility is limited.

Left: Emergency exit doors have small text on signage, without icons. The door also has a high and narrow vision panel.

Currently, vision panels on emergency exit doors are high. This is a hazard for those who are shorter, who may open the door into another person.

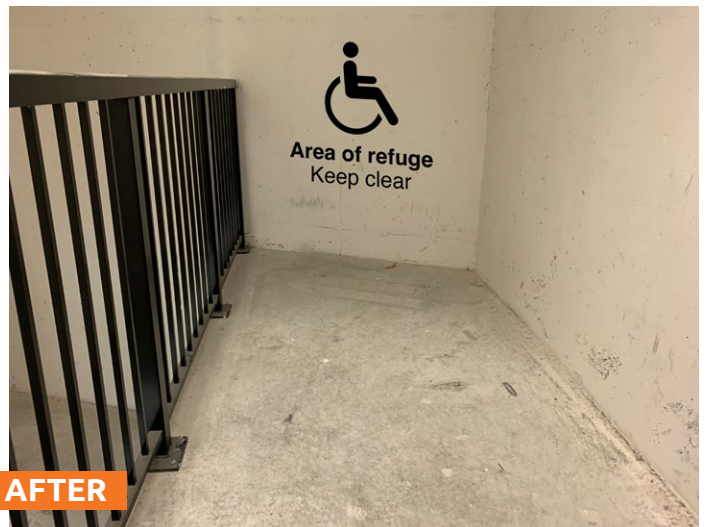
Currently, areas of refuge are not clearly marked. This can lead the space to be cluttered and used for storage, which is a hazard for emergency situations where the space is needed.

Left: Area of refuge lacks signage, which can prevent the space being used for storage.

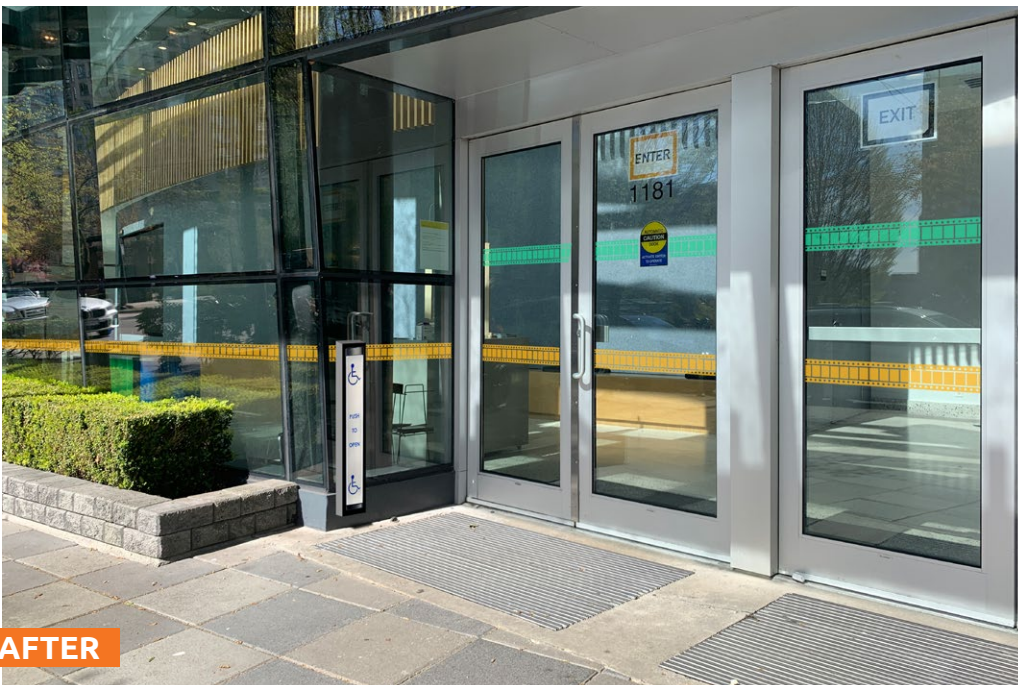
Top: Glazed entrance doors and walls lack markings or strips on the glass. Power-operated door button is at one height and clear space is obstructed by shrubbery.

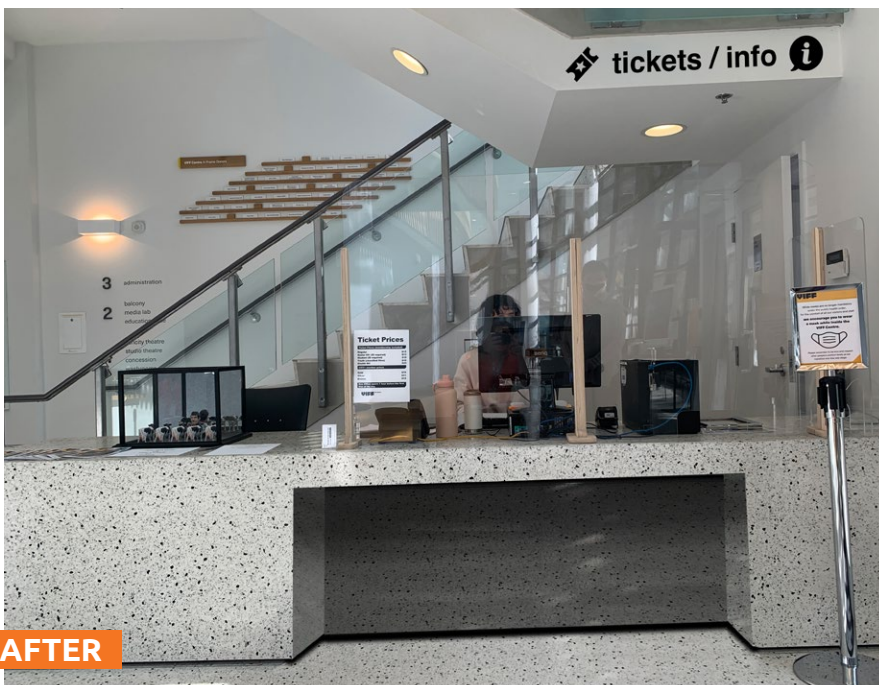
Top: Information desk has no knee clearance for approach by wheelchair users. There is no signage.
